URGENT FIELD SAFETY NOTICE

FSCA identifier: HV-SAL-2018-001
Affected Product: Perceval Sutureless Heart Valve
Type of action: Advice given by the Manufacturer regarding the use of the device
Date: June 18, 2018
Attention: Implanting Surgeons
Reason: Possibility of stent folding due to Perceval valve oversizing

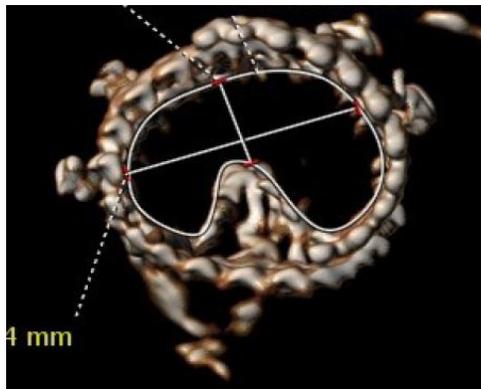
Stent folding is defined as an inward deformation of the stent at the annulus level (see Figure 1).

Figure 1. Stent folding

The main root cause identified for stent folding is valve oversizing, associated with other factors such as:

- extremely eccentric aortic annulus;
- highly calcified portion of the annulus, or uneven decalcification (concentrated bulky calcium protrusion);
- aortic root anatomy deviating from the tri-symmetrical physiological geometry (bicuspid valve, or absence of one of the Valsalva sinuses);
- severe hypertrophic septum.

Valve folding could result in paravalvular or central leakage, in some cases associated with high gradient, which may be significant enough to require a reoperation.

- 1) Decalcification, to avoid uneven surfaces;
- 2) Correct sizing, using available information in the IFU; and
- 3) Ballooning, with the recommendation to pour warm sterile saline (at 37°C) while ballooning.

- 1) Visual inspection, checking that the Perceval stent is correctly deployed; and
- 2) Performing an intraoperative echographic evaluation after Perceval implant to confirm correct positioning and verify valve functionality under beating heart conditions.
